Harness Structural test Report - EN / NfL

Inspection certificate number: **PH_489.2025**

Name:	**The BoxR**
Type:	**ABS**
Size:	**L**
Serial number:	**AN2506 7587-0**
Impact pad type: (1)	**Inflatable**
Clip-in weight [kg]:	**120**
Date of test:	**18.07.2025**

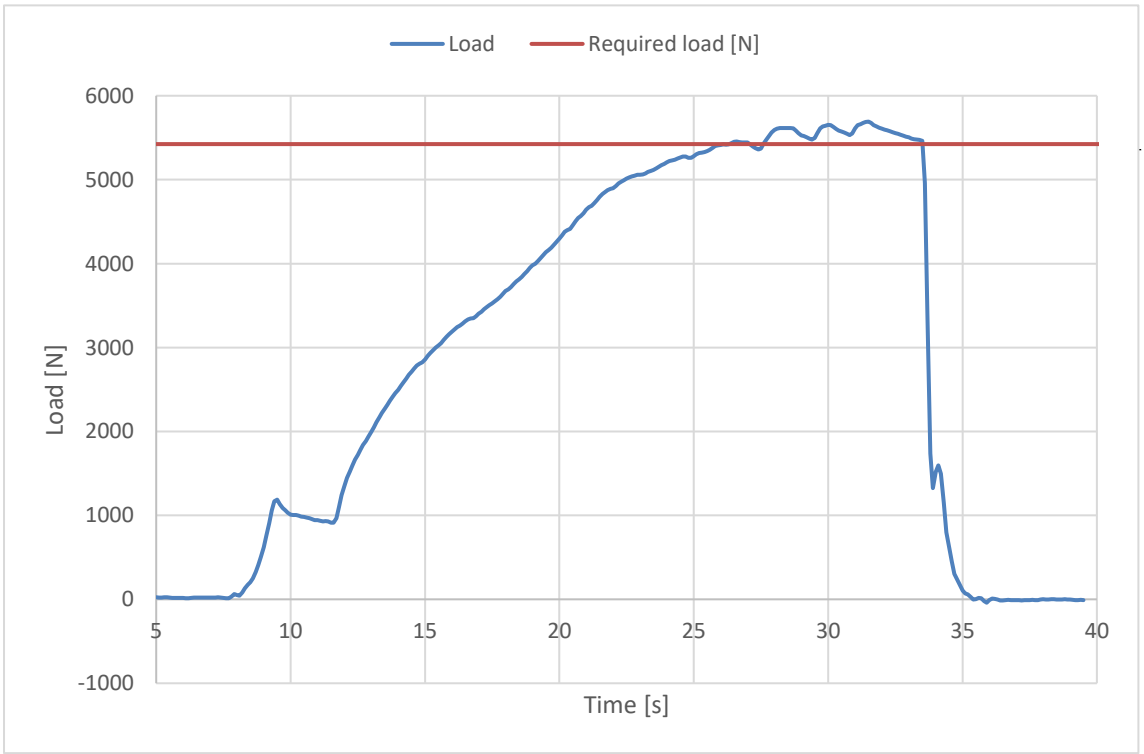
Harness Structural test **Test ID 01**

Standard	**EN 1651 / NfL 2024-2-785**
Reference in standard	**5.5.1.1**
Test setup	**Positive symmetric load (Slippage)**
Attachment points	**Both main riser attachment (3,4)**
Anchor points	**Dummy (B1, B2)**
Required load [g]	**4.5**
Required load [N]	**5400**
Minimum test duration [s]	**5**
Result	
Test duration [s]	**6**
Any signs of structural failure	**No**
Slippery test OK	**Yes**
Test results	**POSITIVE**

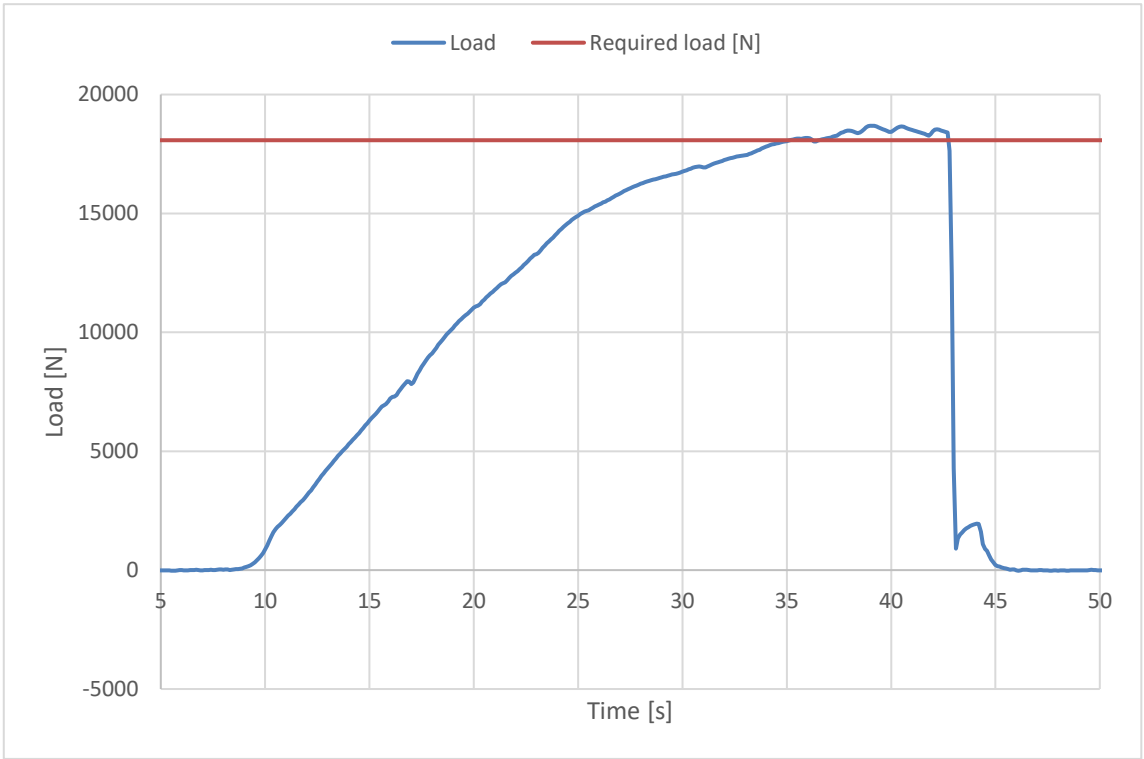
Harness Structural test **Test ID 03**

Standard	**EN 1651 / NfL 2024-2-785**
Reference in standard	**5.5.1.1b**
Test setup	**Positive symmetric load**
Attachment points	**Both main riser attachment (3,4)**
Anchor points	**Dummy (B1, B2)**
Required load [g]	**15**
Required load [N]	**18000**
Minimum test duration [s]	**5**
Result	
Test duration [s]	**6.2**
Any signs of structural failure	**No**
Slippery test OK	**Yes**
Test results	**POSITIVE**

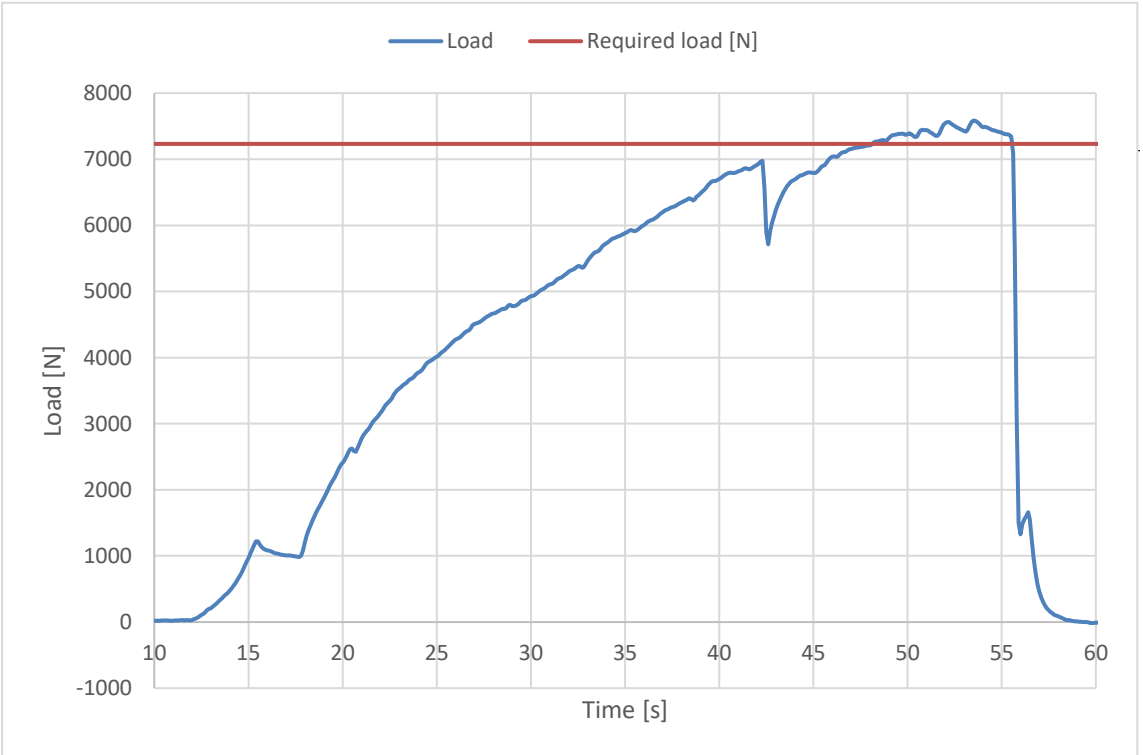
Harness Structural test **Test ID 05**

Standard	**EN 1651 / NfL 2024-2-785**
Reference in standard	**5.5.1.2**
Test setup	**Positive asymmetric load**
Attachment points	**One riser attachment (3 or 4)**
Anchor points	**Dummy (C)**
Required load [g]	**6**
Required load [N]	**7200**
Minimum test duration [s]	**5**
Result	
Test duration [s]	**7.4**
Any signs of structural failure	**No**
Test results	**POSITIVE**

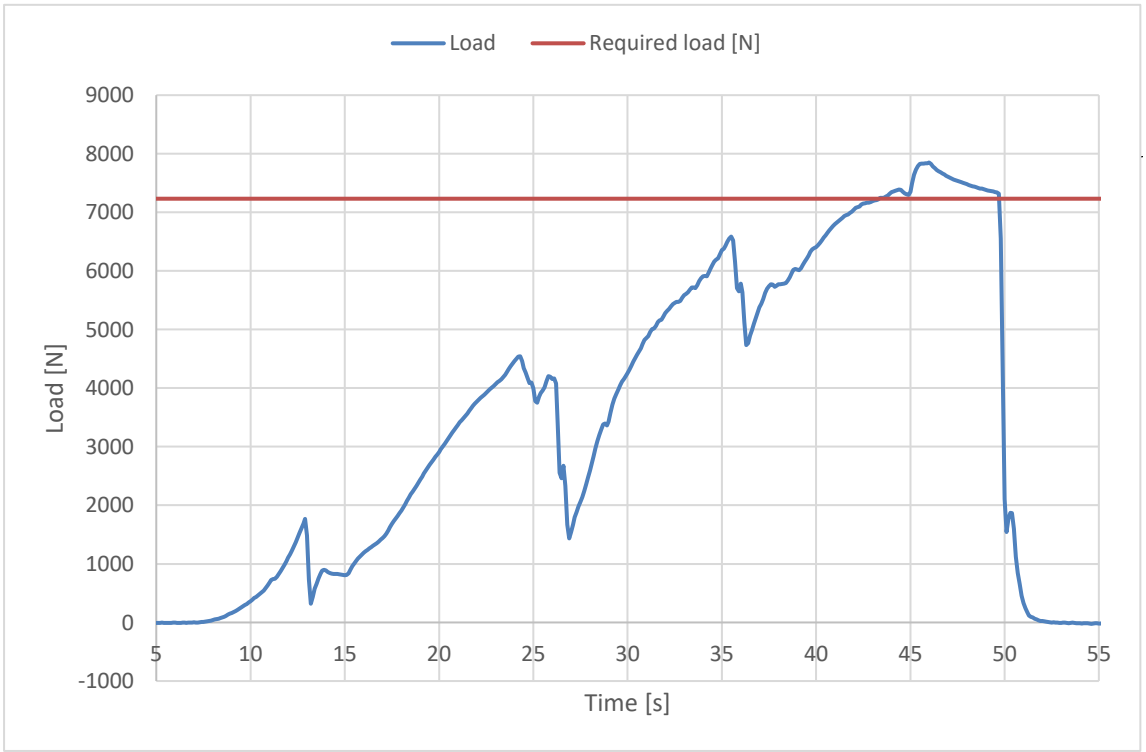
Harness Structural test **Test ID 06**

Standard	**EN 1651 / NfL 2024-2-785**
Reference in standard	**5.5.1.6**
Test setup	**Negative symmetric load**
Attachment points	**Both main riser attachment (3,4)**
Anchor points	**Dummy (A)**
Required load [g]	**6**
Required load [N]	**7200**
Minimum test duration [s]	**5**
Result	
Test duration [s]	**6.4**
Any signs of structural failure	**No**
Test results	**POSITIVE**

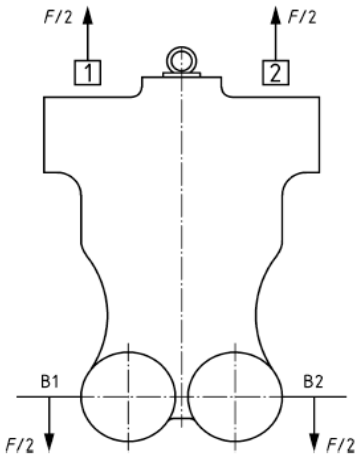
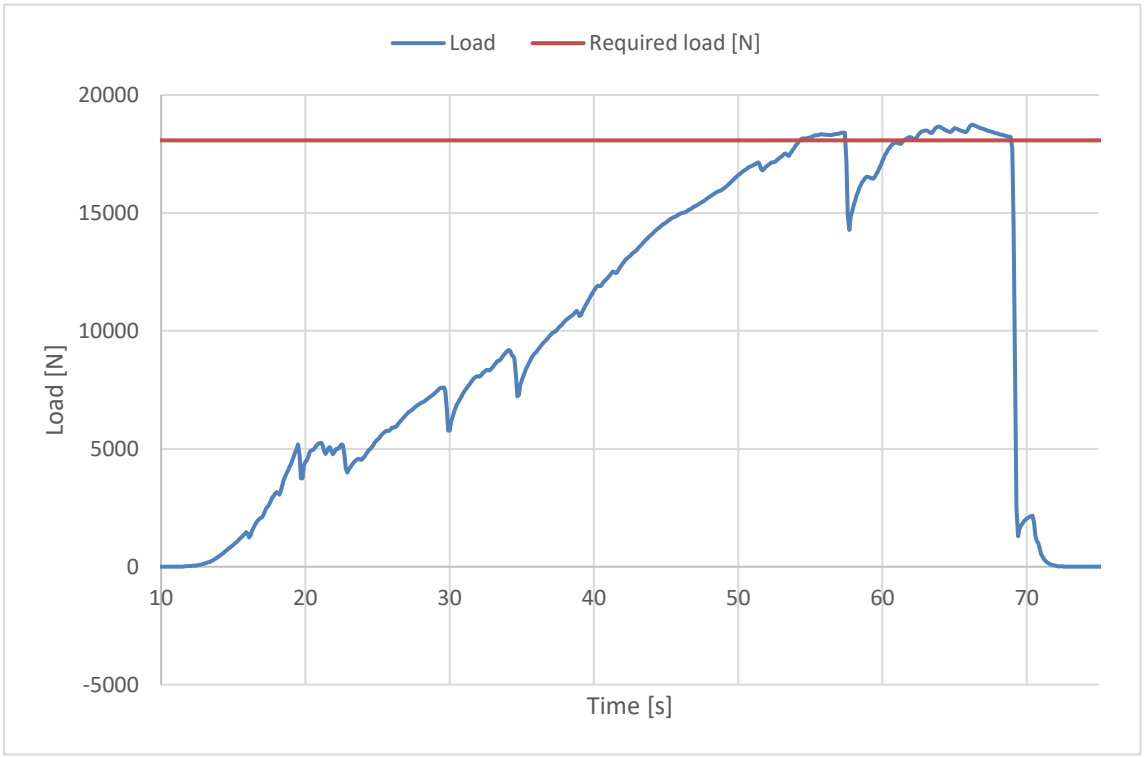
Harness Structural test **Test ID 09**

Standard	**EN 1651 / NfL 2024-2-785**
Reference in standard	**5.5.1.3**
Test setup	**Positive symmetric load rescue points**
Attachment points	**Both main riser attachment (1,2)**
Anchor points	**Dummy (B1,B2)**
Required load [g]	**15**
Required load [N]	**18000**
Minimum test duration [s]	**5**
Result	
Test duration [s]	**7.5**
Any signs of structural failure	**No**
Slippery test OK	**Yes**
Test results	**POSITIVE**

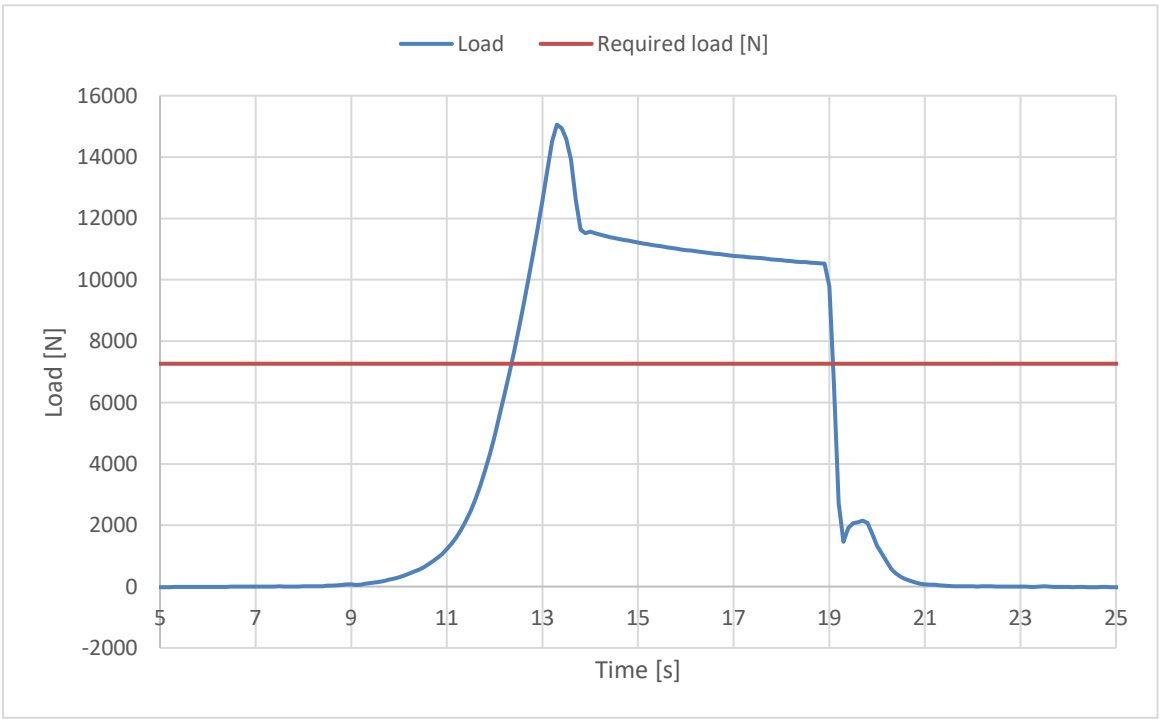
Harness Structural test		**Test ID 12**
Standard	**EN 1651 / NfL 2024-2-785**	
Reference in standard	**5.5.1.7**	
Test setup	**Upright (landing) position load**	
Attachment points	**Both main riser attachment (3, 4)**	
Anchor points	**Both legstrap of harness (no dummy)**	
Required load [g]	**6**	
Required load [N]	**7200**	
Minimum test duration [s]	**5**	
Harness type	**type b**	
Result		
Test duration [s]	**6.7**	
Any signs of structural failure	**No**	
Slippery test OK	**Yes**	
Test results	**POSITIVE**

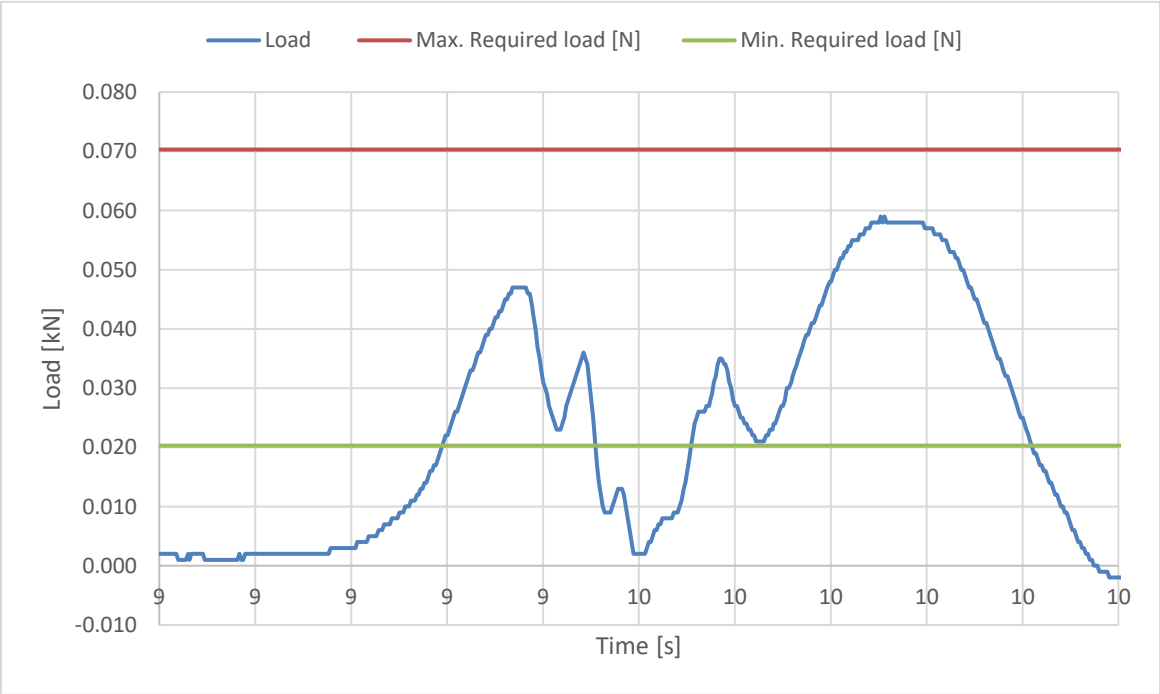
Rescue Deployment Test		**Test ID RDT**
Standard	**EN 1651 / NfL 2024-2-785**	
Reference in standard	**5.5.1.11**	
Test setup	**Default flying position**	
Attachment points	**Sensor connect to handle, and pull in opening direction**	
	The test is to simulate the load required to open the emergency parachute(1st action).	
Min. Required load [N]	**20**	
Max. Required load [N]	**70**	
Result		
Load for first action [N]	**59.30**	
Test results	**POSITIVE**

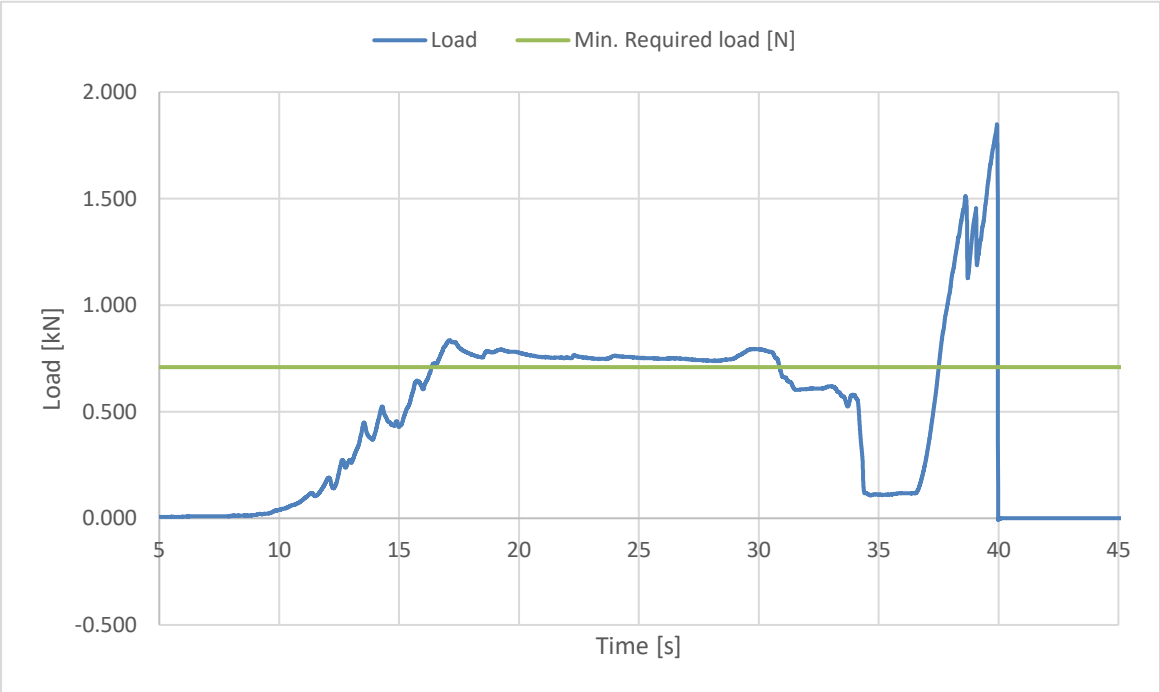
Rescue Deployment Handle strength test		**Test ID RST**
Standard	**EN 1651 / NfL 2024-2-785**	
Reference in standard	**5.3.2**	
Test setup	**Two end points of handle**	
Attachment points	**Sensor connect to end of handle, pull on the other side**	
	The handle must support min 700 N for 10 s, after measure breaking strength	
Min. Required load [N]	**700**	
Minimum test duration [s]	**10**	
Result		
Test duration [s]:	**18.1**	
Breaking strength [N]	**1839.50**	
Test results	**POSITIVE**
