Harness Structural test Report - EN

Inspection certificate number: **PH_300.2020**

Name:	**Walibi 3**
Type:	**ABS**
Size:	**M**
Serial number:	**WI3-M_V9.1**
Impact pad type: (1)	**Foam**
Clip-in weight [kg]:	**120**
Date of test:	**22.05.2020**

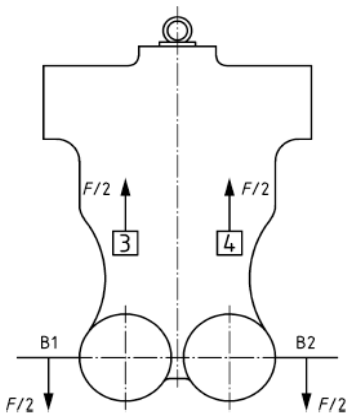
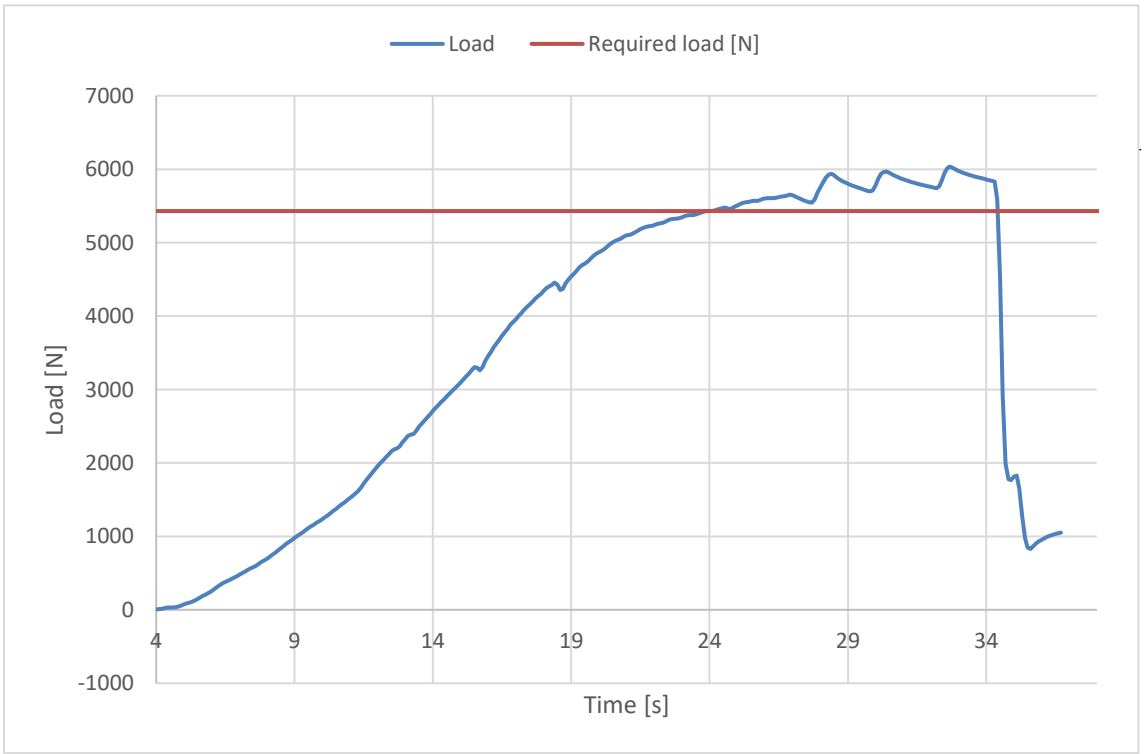
Harness Structural test **Test ID 01**

Standard	**EN 1651**
Reference in standard	**5.5.1.1**
Test setup	**Positive symmetric load (Slippage)**
Attachment points	**Both main riser attachment (3,4)**
Anchor points	**Dummy (B1, B2)**
Required load [g]	**4.5**
Required load [N]	**5400**
Minimum test duration [s]	**5**
Result	
Test duration [s]	**10.4**
Any signs of structural failure	**No**
Slippery test OK	**No**
Test results	**POSITIVE**

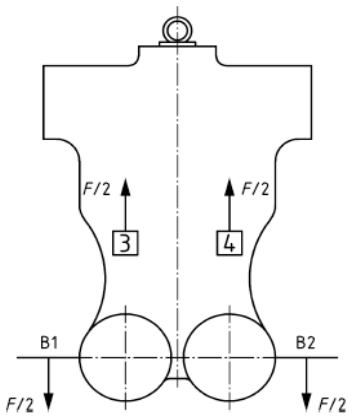
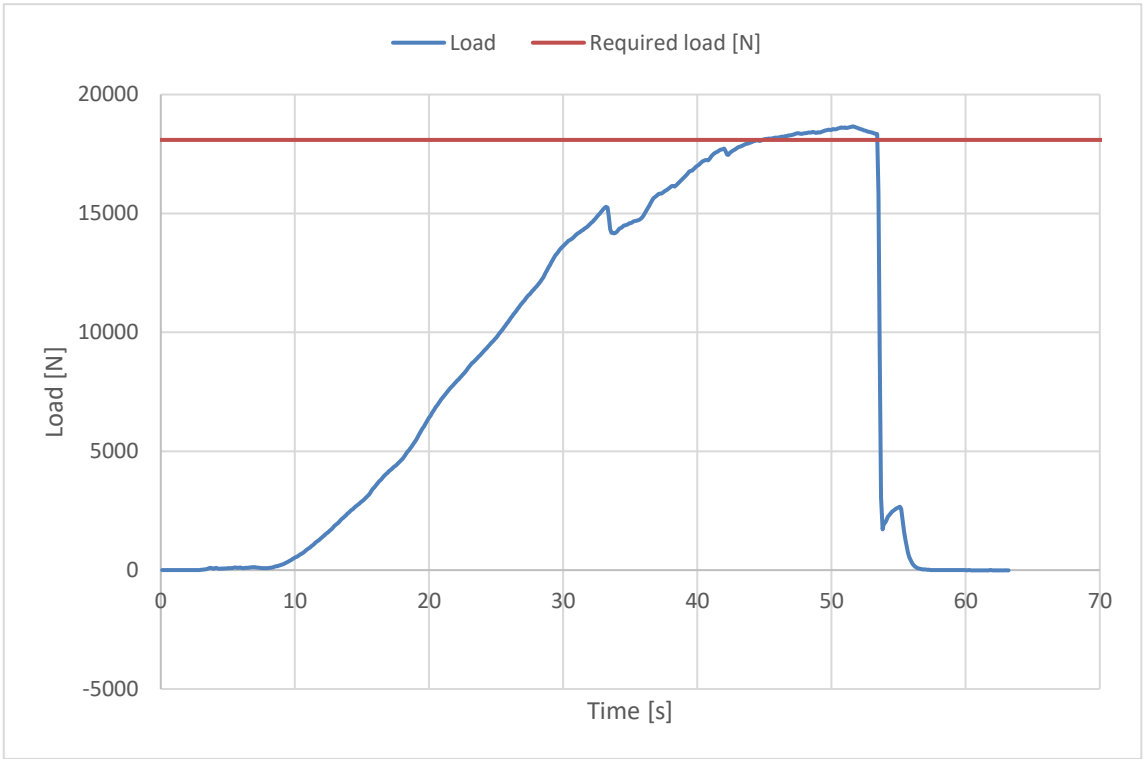
Harness Structural test **Test ID 03**

Standard	**EN 1651**
Reference in standard	**5.5.1.1b**
Test setup	**Positive symmetric load**
Attachment points	**Both main riser attachment (3,4)**
Anchor points	**Dummy (B1, B2)**
Required load [g]	**15**
Required load [N]	**18000**
Minimum test duration [s]	**5**
Result	
Test duration [s]	**8.6**
Any signs of structural failure	**No**
Slippery test OK	**No**
Test results	**POSITIVE**

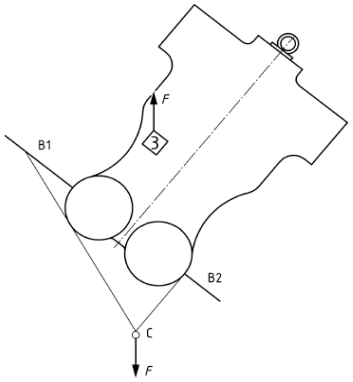
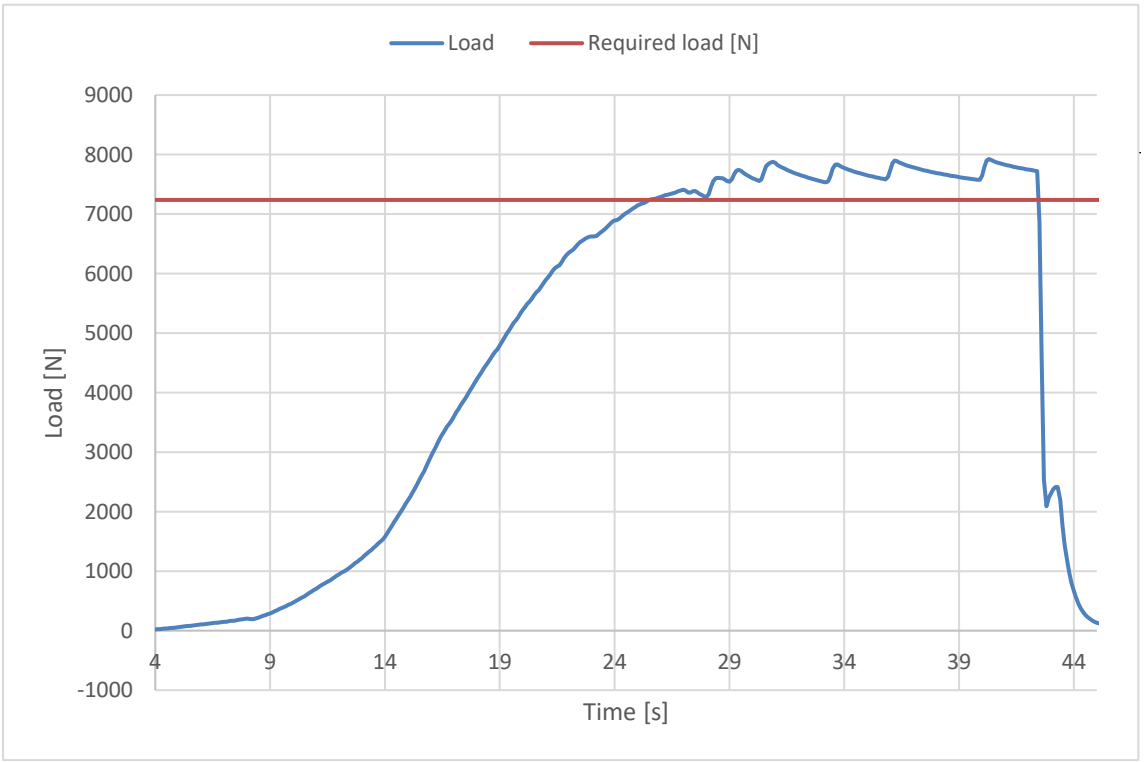
Harness Structural test **Test ID 05**

Standard	**EN 1651**
Reference in standard	**5.5.1.2**
Test setup	**Positive asymmetric load**
Attachment points	**One riser attachment (3 or 4)**
Anchor points	**Dummy (C)**
Required load [g]	**6**
Required load [N]	**7200**
Minimum test duration [s]	**5**
Result	
Test duration [s]	**16.9**
Any signs of structural failure	**No**
Test results	**POSITIVE**

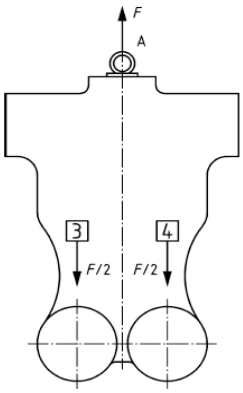
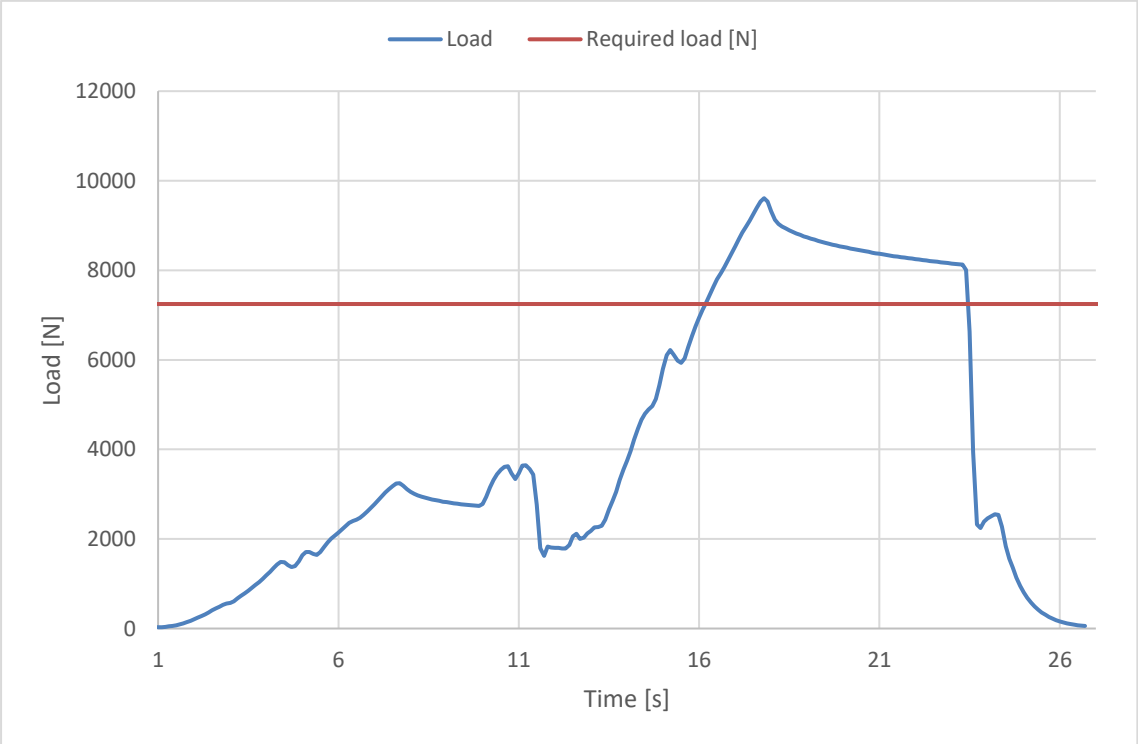
Harness Structural test **Test ID 06**

Standard	**EN 1651**
Reference in standard	**5.5.1.6**
Test setup	**Negative symmetric load**
Attachment points	**Both main riser attachment (3,4)**
Anchor points	**Dummy (A)**
Required load [g]	**6**
Required load [N]	**7200**
Minimum test duration [s]	**5**
Result	
Test duration [s]	**7.3**
Any signs of structural failure	**No**
Test results	**POSITIVE**

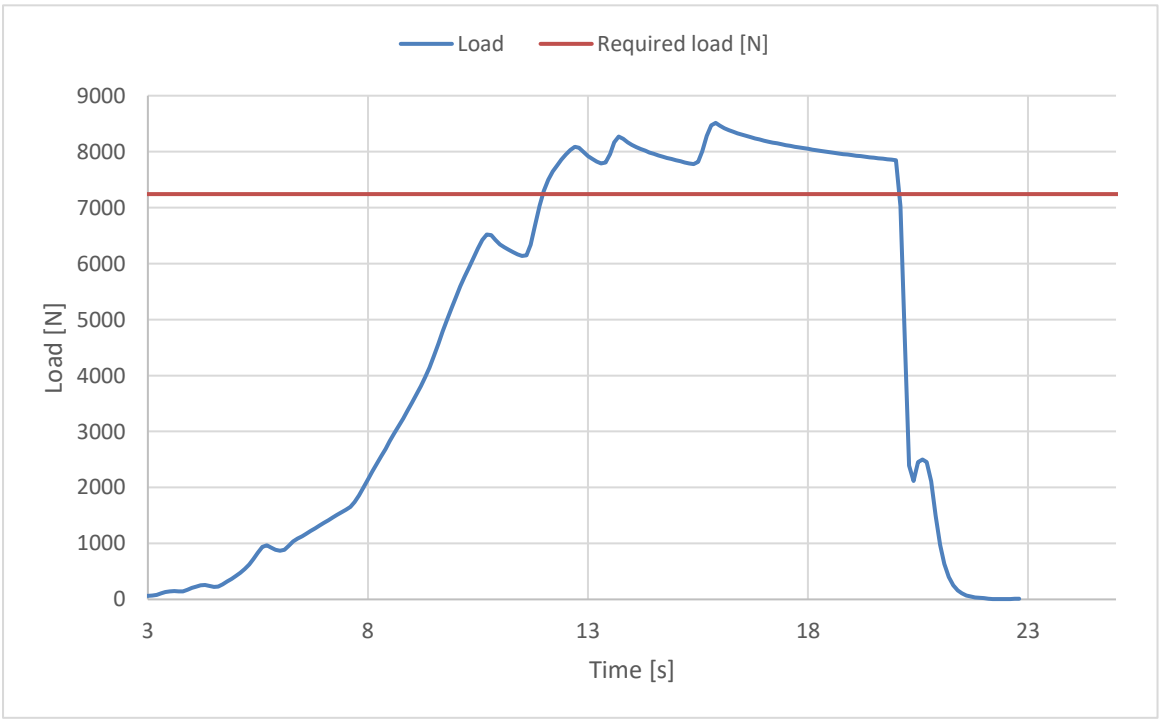
Harness Structural test **Test ID 12**

Standard	**EN 1651**
Reference in standard	**5.5.1.7**
Test setup	**Upright (landing) position load**
Attachment points	**Both main riser attachment (3, 4)**
Anchor points	**Both legstrap of harness (no dummy)**
Required load [g]	**6**
Required load [N]	**7200**
Minimum test duration [s]	**5**
Harness type	**type a**

Test duration [s]	**8.1**
Any signs of structural failure	**No**
Slippery test OK	**No**
Test results	**POSITIVE**

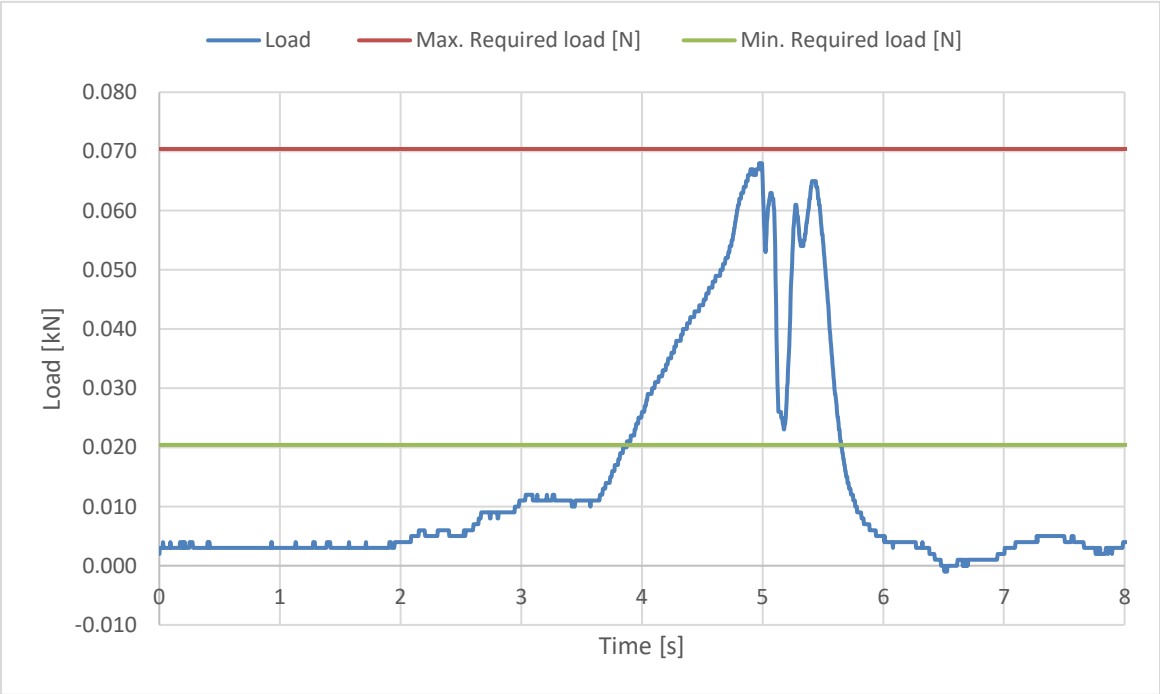
Rescue Deployment Test		**Test ID RRDT**
Standard	**LTF NfL II 91/09**	
Reference in standard	**6.1.5**	
Test setup	**Default flying position**	
Attachment points	**Sensor connect to handle, and pull in opening direction**	
	The test is to simulate the load required to open the emergency parachute(1st action).	
Min. Required load [N]	**20**	
Max. Required load [N]	**70**	
Result		
Load for first action [N]	**67.59**	
Test results	**POSITIVE**

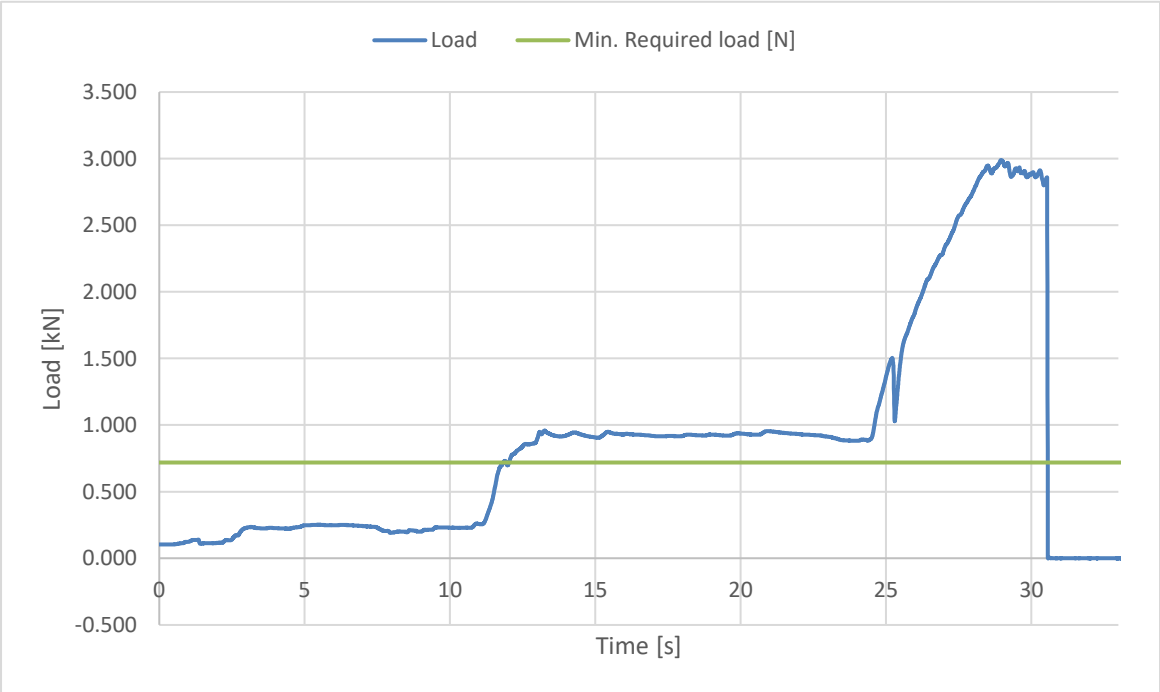
Rescue Deployment Handle strength test		**Test ID RRST**
Standard	**EN12491:2015**	
Reference in standard	**5.3.2**	
Test setup	**Two end points of handle**	
Attachment points	**Sensor connect to end of handle, pull on the other side**	
	The handle must support min 700 N for 10 s, after measure breaking strength	
Min. Required load [N]	**700**	
Minimum test duration [s]	**10**	
Result		
Test duration [s]:	**18.5**	
Breaking strength [N]	**2973.03**	
Test results	**POSITIVE**
