Harness Structural test Report - LTF

Inspection certificate number: **PH_300.2020**

Name:	**Walibi 3**
Type:	**ABS**
Size:	**M**
Serial number:	**WI3-V9.1**
Impact pad type: (1)	**Foam**
Clip-in weight [kg]:	**120**
Date of test:	**22.05.2020**

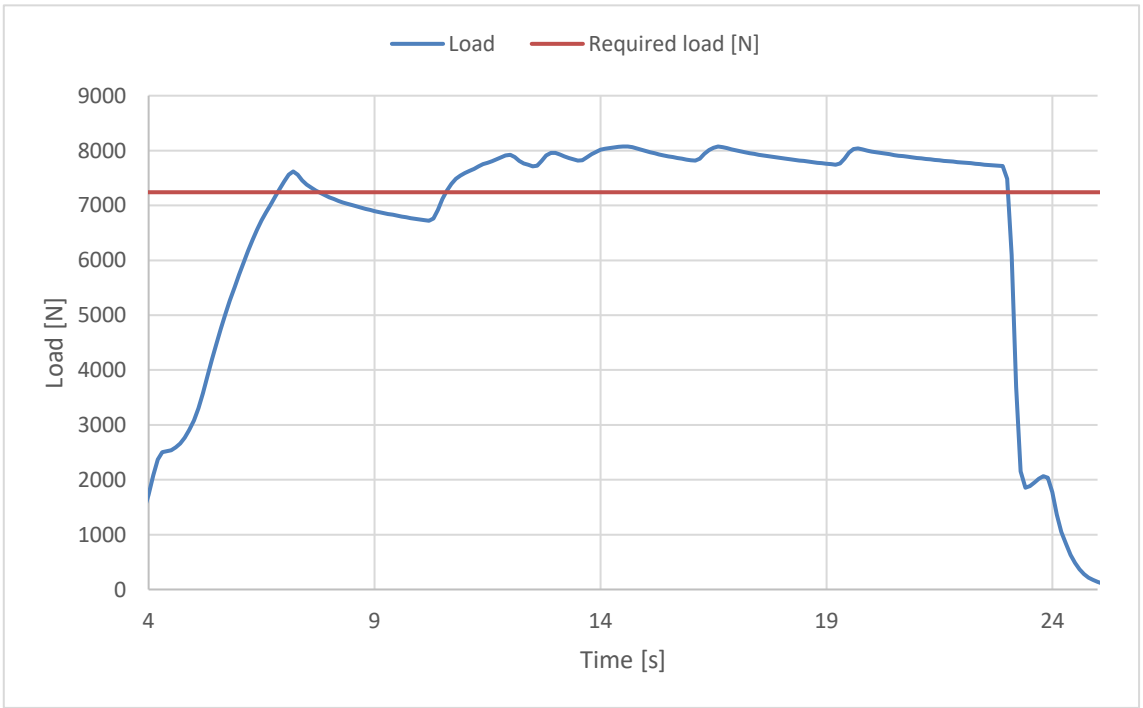
Harness Structural test **Test ID 02**

Standard	**LTF NfL II 91/09**
Reference	**5.3.2.1**
Test setup	**Default flying position**
Attachment points	**Both main riser attachment (3,4)**
Anchor points	**Dummy (B1, B2)**
Required load [g]	**6**
Required load [N]	**7200**
Minimum test duration [s]	**10**
Result	
Test duration [s]	**12.5**
Any signs of structural failure	**No**
Test results	**POSITIVE**

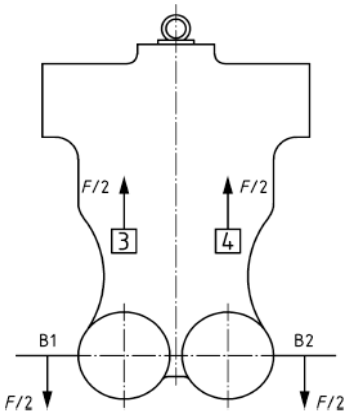
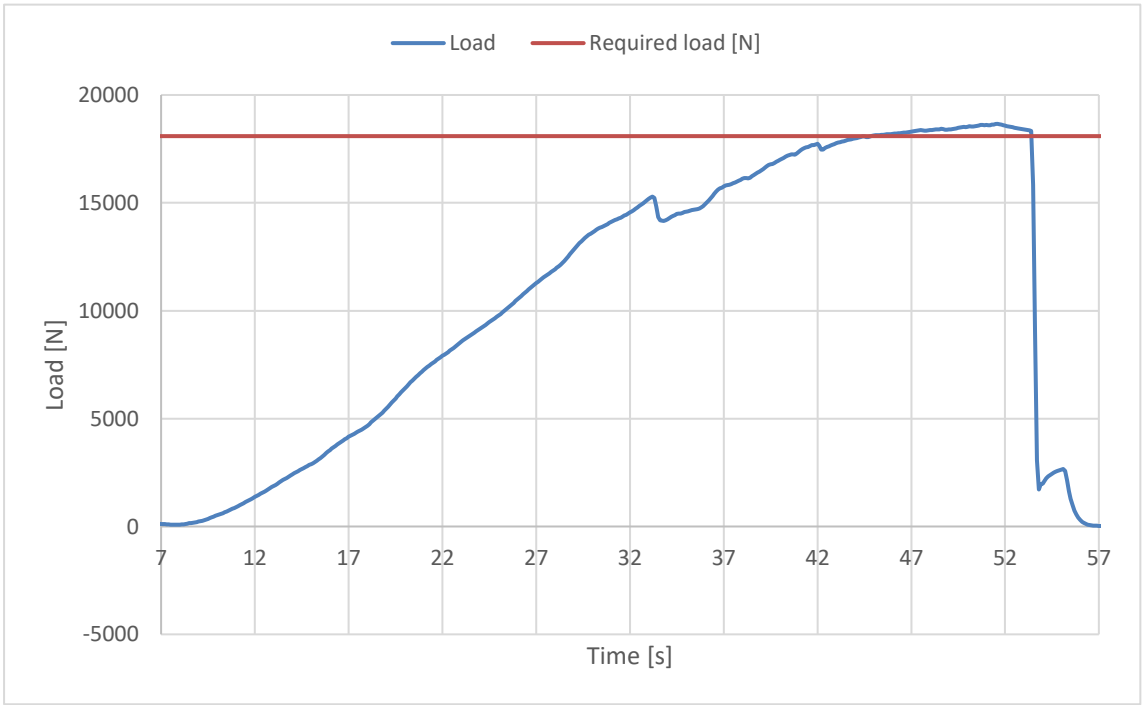
Harness Structural test **Test ID 03**

Standard	**LTF NfL II 91/09**
Reference	**5.3.2.2**
Test setup	**Default flying position**
Attachment points	**Both main riser attachment (3,4)**
Anchor points	**Dummy (B1, B2)**
Required load [g]	**15**
Required load [N]	**18000**
Minimum test duration [s]	**5**
Result	
Test duration [s]	**8.6**
Any signs of structural failure	**No**
Test results	**POSITIVE**

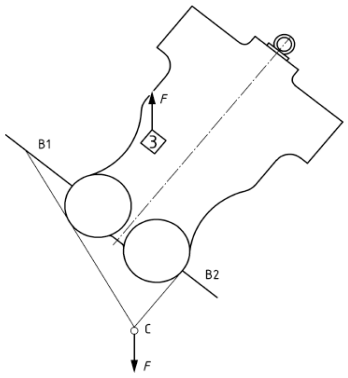
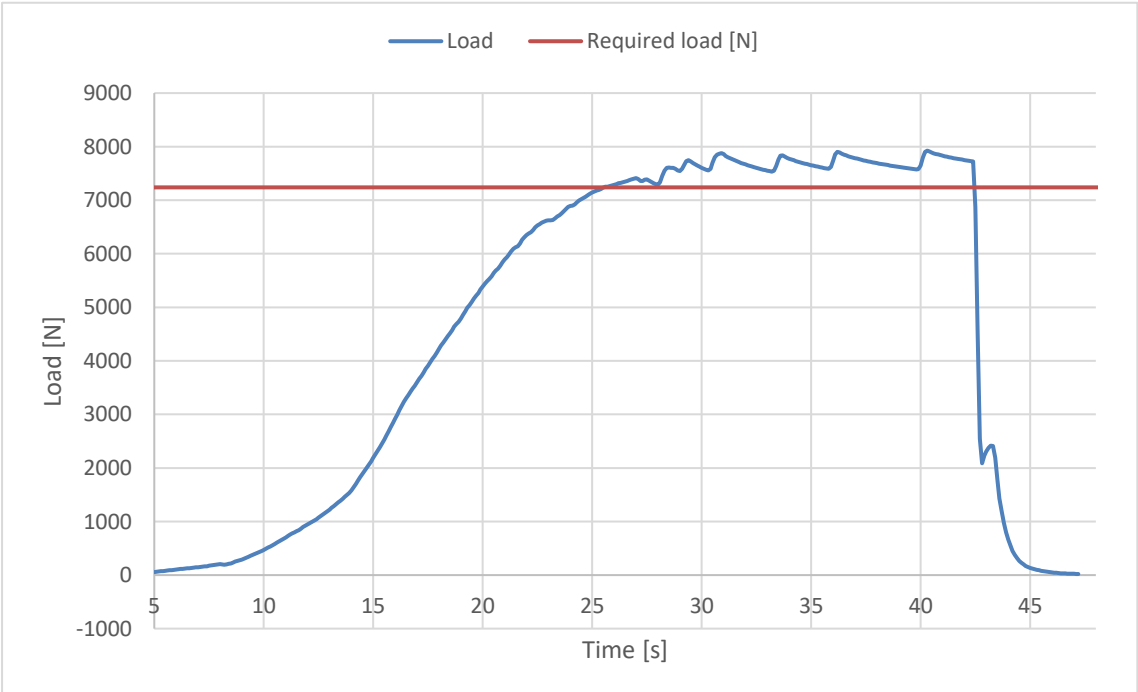
Harness Structural test **Test ID 04**

Standard	**LTF NfL II 91/09**
Reference	**5.3.2.3**
Test setup	**Asymmetric, one riser**
Attachment points	**One main riser attachment (3)**
Anchor points	**Dummy (B1,B2)**
Required load [g]	**6**
Required load [N]	**7200**
Minimum test duration [s]	**10**
Result	
Test duration [s]	**16.9**
Any signs of structural failure	**No**
Test results	**POSITIVE**

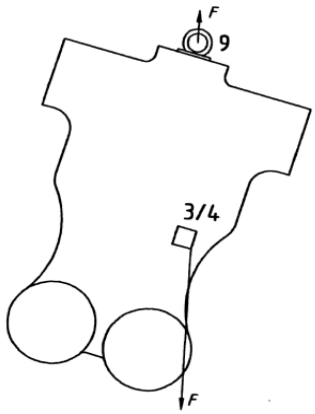
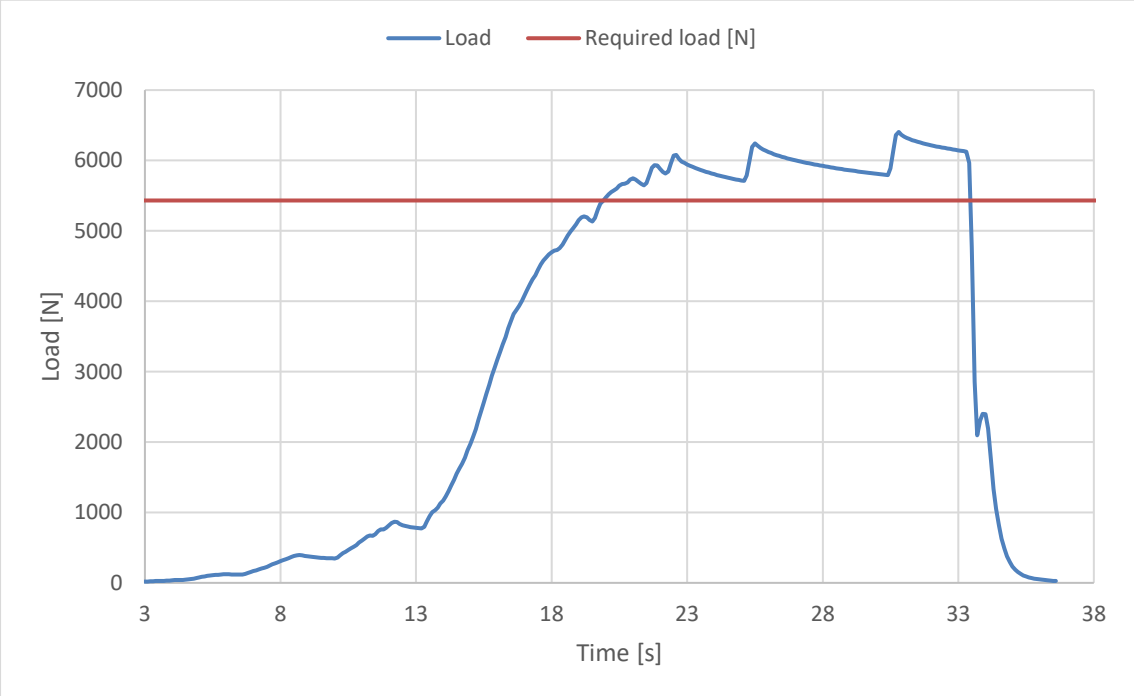
Harness Structural test **Test ID 07**

Standard	**LTF NfL II 91/09**
Reference	**5.3.2.6**
Test setup	**Asymmetric, negative**
Attachment points	**One main riser attachment (3 or 4) downwards**
Anchor points	**Dummy (9)**
Required load [g]	**4.5**
Required load [N]	**5400**
Minimum test duration [s]	**10**

Test duration [s]	**13.5**
Any signs of structural failure	**No**
Test results	**POSITIVE**

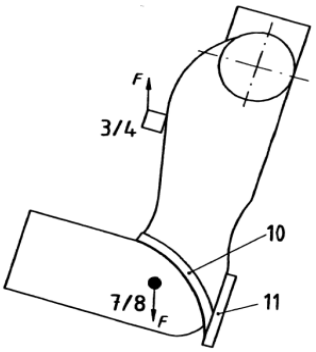
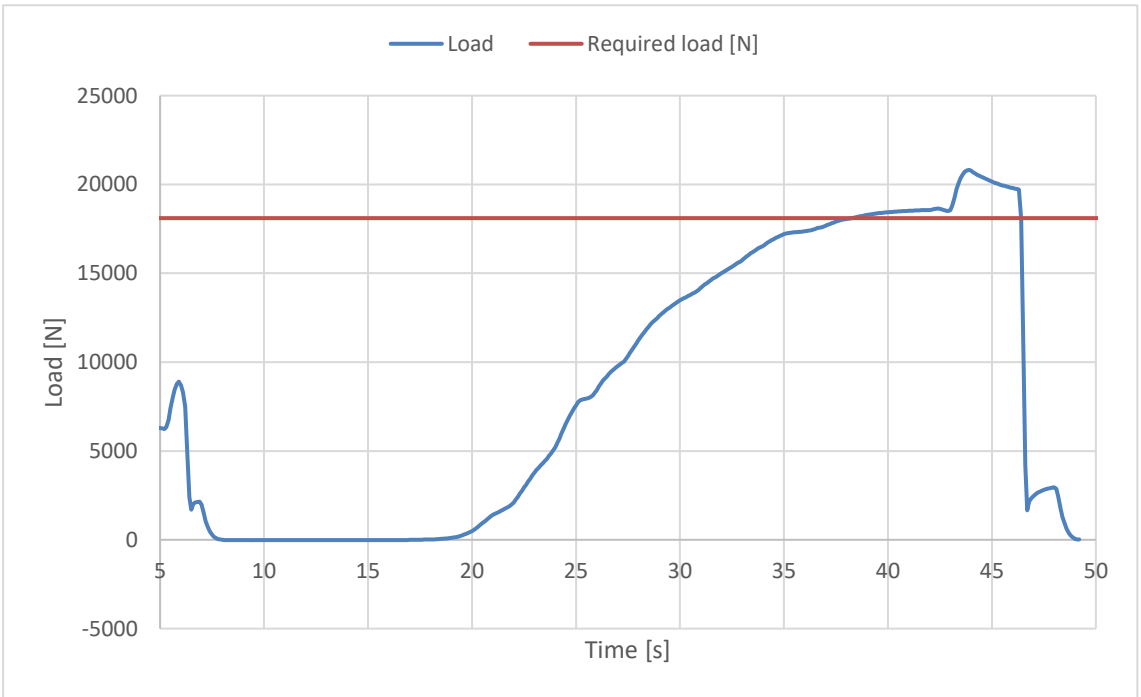
Harness Structural test **Test ID 13**

Standard	**LTF NfL II 91/09**
Reference	**5.3.2.7**
Test setup	**Flying position before landing**
Attachment points	**Both main riser attachment (3,4)**
Anchor points	**Dummy (7,8)**
Required load [g]	**15**
Required load [N]	**18000**
Minimum test duration [s]	**5**
Result	
Test duration [s]	**8.1**
Any signs of structural failure	**No**
Test results	**POSITIVE**

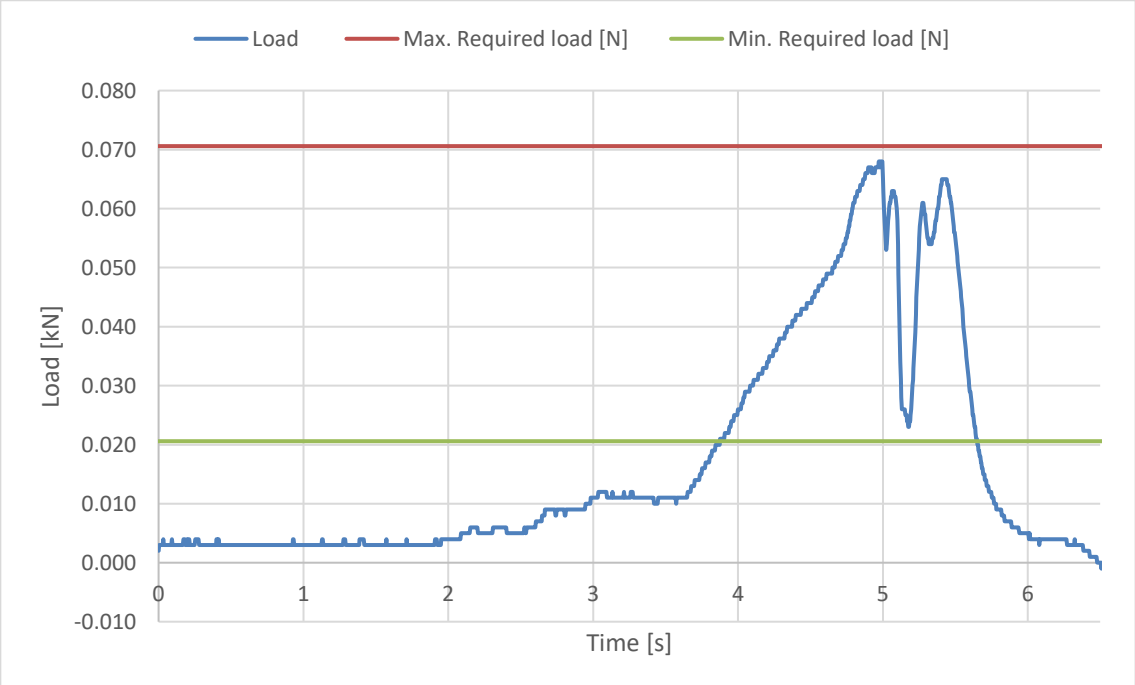
Rescue Deployment Test		**Test ID RRDT**
Standard	**LTF NfL II 91/09**	
Reference	**6.1.5**	
Test setup	**Default flying position**	
Attachment points	**Sensor connect to handle, and pull in opening direction**	
	The test is to simulate the load required to open the emergency parachute(1st action).	
Min. Required load [N]	**20**	
Max. Required load [N]	**70**	
Result		
Load for first action [N]	**67.41**	
Test results	**POSITIVE**

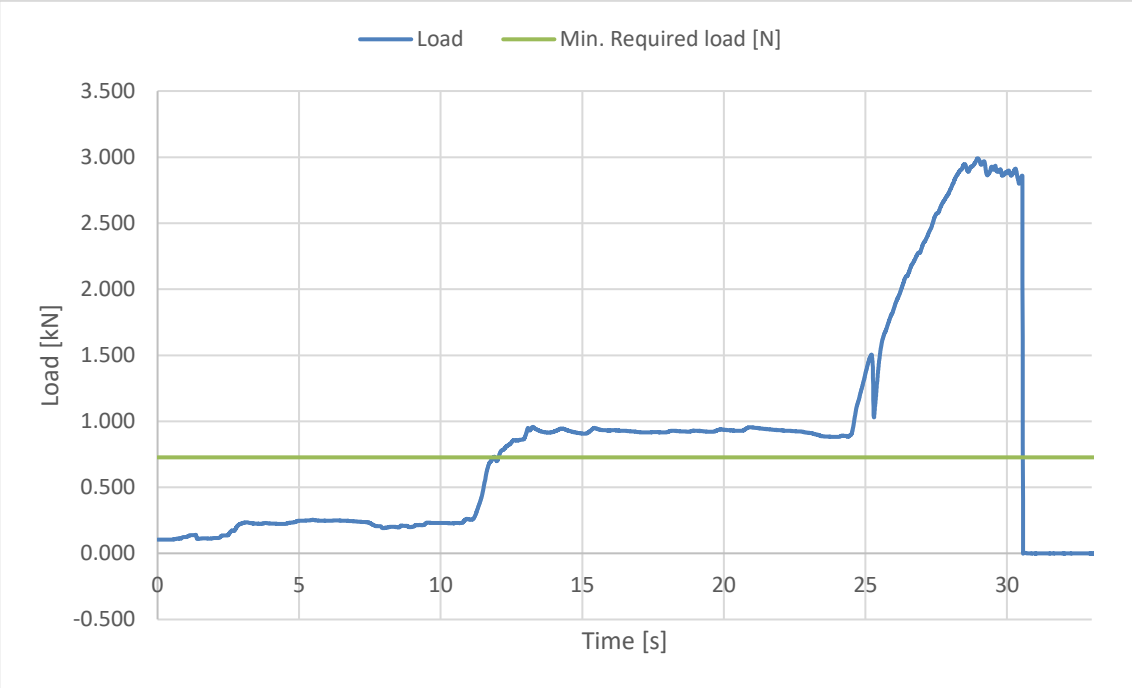
Rescue Deployment Handle strength test		**Test ID RRST**
Standard	**EN12491:2015**	
Reference in standard	**5.3.2**	
Test setup	**Two end points of handle**	
Attachment points	**Sensor connect to end of handle, pull on the other side**	
	The handle must support min 700 N for 10 s, after measure breaking strength	
Min. Required load [N]	**700**	
Minimum test duration [s]	**10**	
Result		
Test duration [s]:	**18.5**	
Breaking strength [N]	**2965.07**	
Test results	**POSITIVE**
